Arboricultural Assessment, Arboricultural Impact and Tree Protection Strategy Report

**Belarmine Park,
Kilgobbin,
Stepaside,
Co. Dublin**

Project No.	TAIK003	Date	02/08/22
Project Name	Aikens Village in the Townland of Woodside, Stepaside, Co. Dublin.	Revision	A

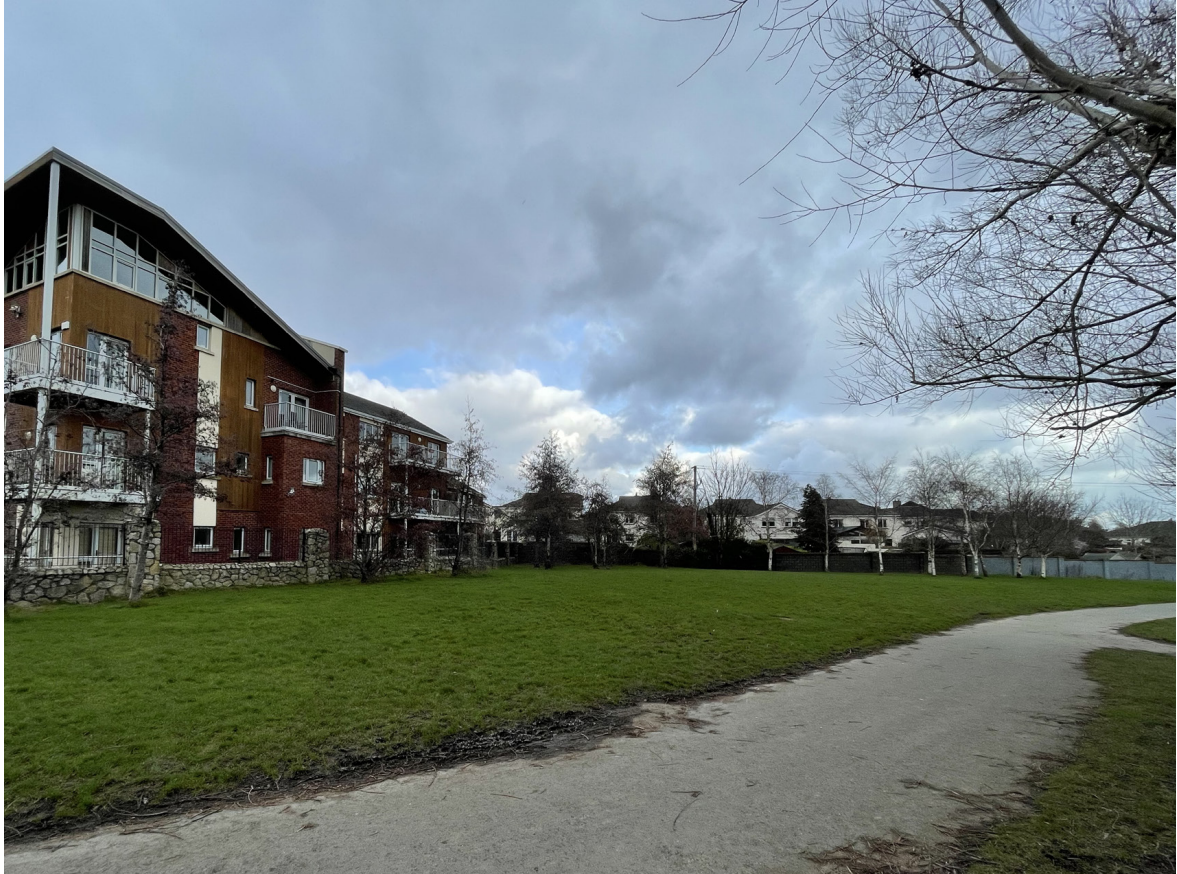
A total of 23 individual trees were identified and assessed (image 2).

Image 2. Overview of survey area in Belarmine Park.

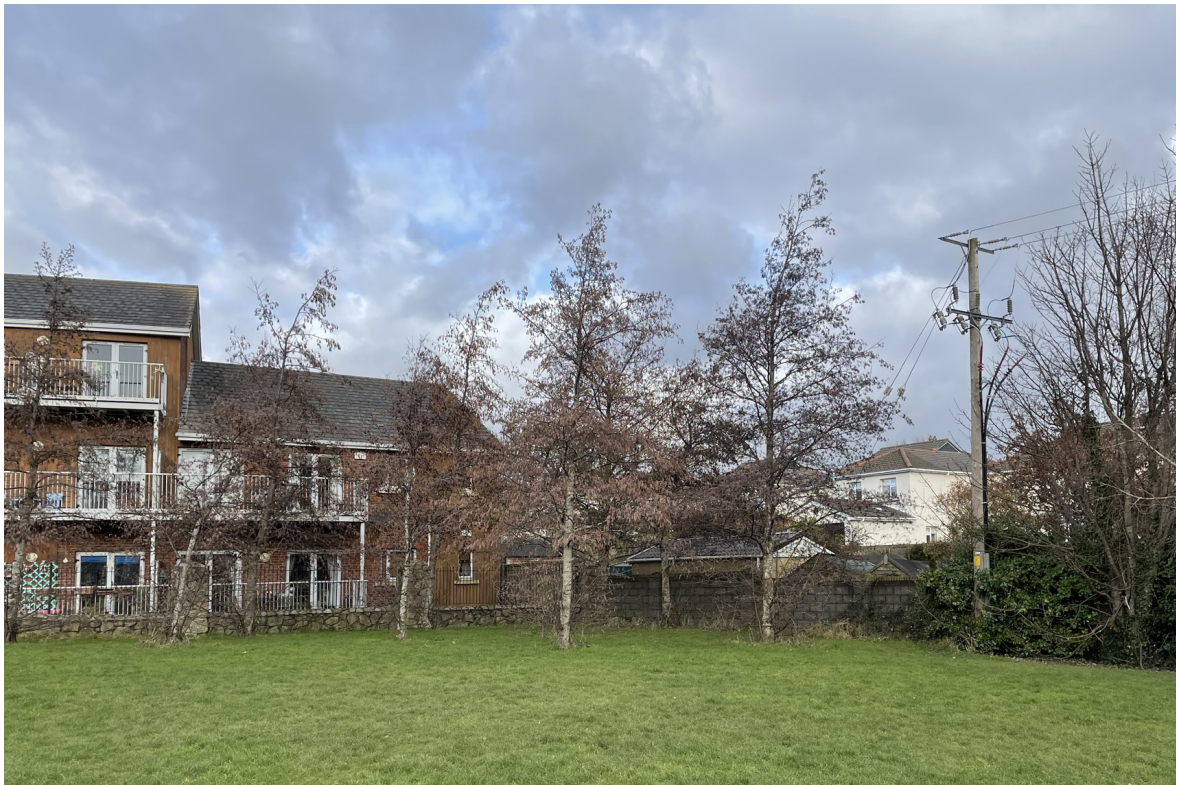
Image 3. Group 13 alder on the northern survey boundary adjacent to Grianan Fidh housing estate.

The loss of four trees will be confined within a group of alder

(*Alnus spp.*) on the northern boundary. These trees provide some screening to the residents in the apartment block directly north. A potential benefit of the removal these four trees will be increased light for the remaining specimens; the larger and more developed of which remain along the north-most edge of the group.

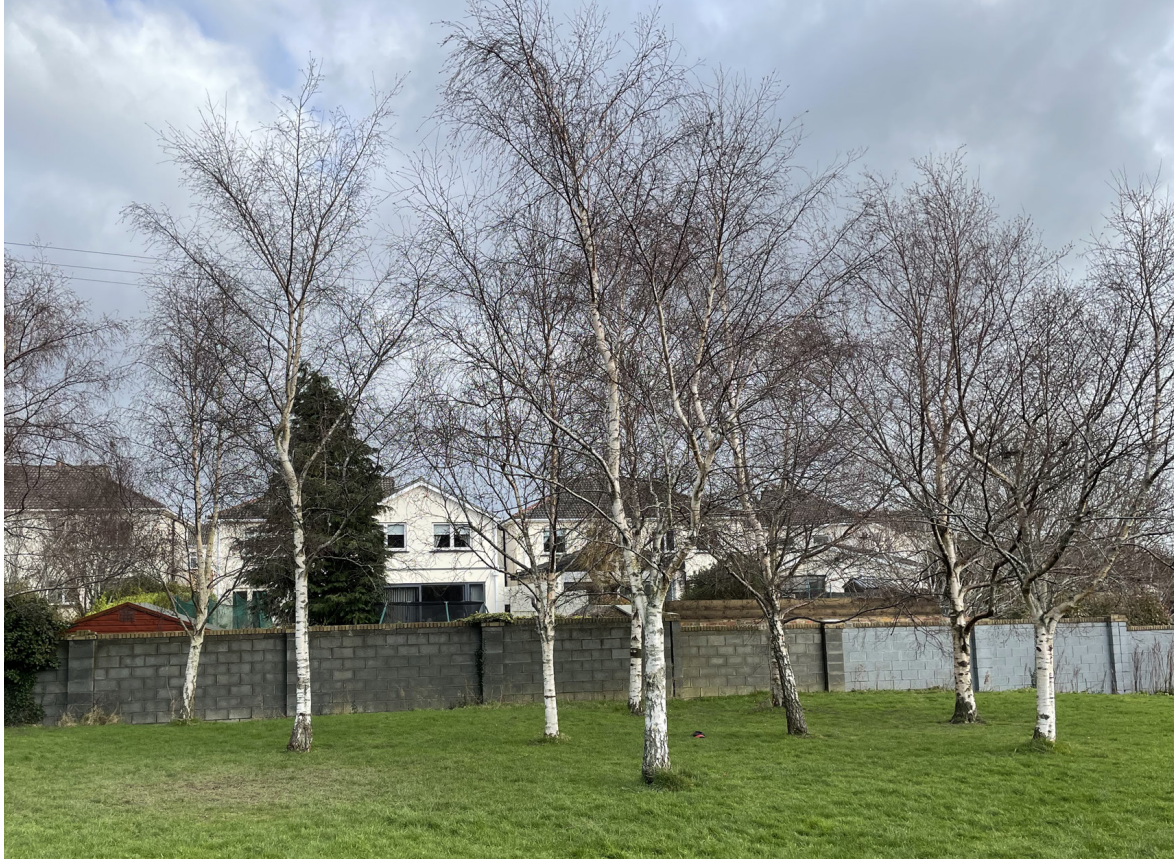
Image 4. Group of 10 birch located adjacent to Sandyford Hall housing estate on the western boundary.
